ERA09LA062
NOVEMBER 19, 2008
GREEN COVE SPRINGS, FLORIDA

AIRBAG SAFETY STUDY FACTUAL

Airbag Safety Study Factual

Location: Green Cove Springs, FL
Aircraft Type: Cirrus SR20-1881
Accident Date: November 19, 2008
Accident Time: 1240 EST
Accident Number: ERA09LA062
Airbag Equipped: ☒

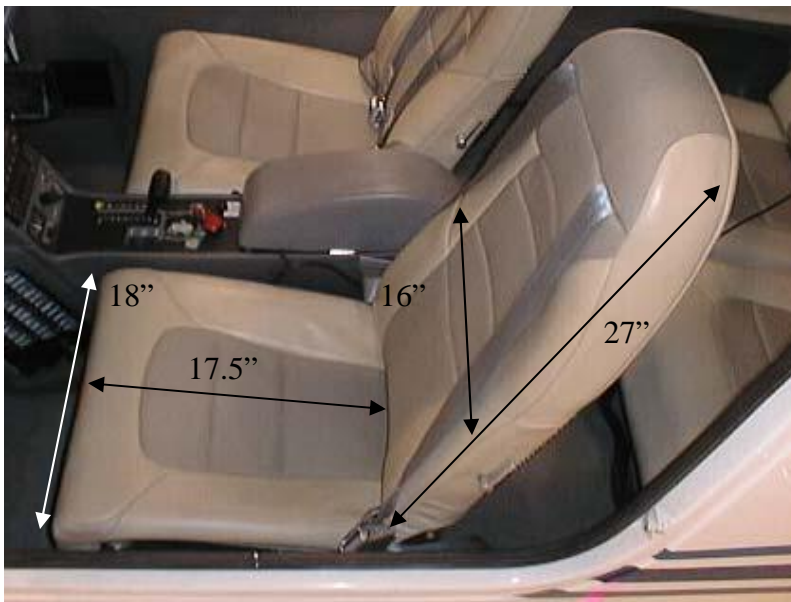
Figure 5: Dimensions of the front seats.

The seats and restraints remained intact, and their dimensions are shown on the exemplar in figure 5. The left seat was found positioned in its tracks 1 adjustment forward of the complete aft position and the right seat was found 4 adjustments forward of the full aft position.
